WARREN H. OHL DAM

INVENTORY NUMBER NDS 394

PHASE I INSPECTION REPORT

NATIONAL DAM INSPECTION PROGRAM

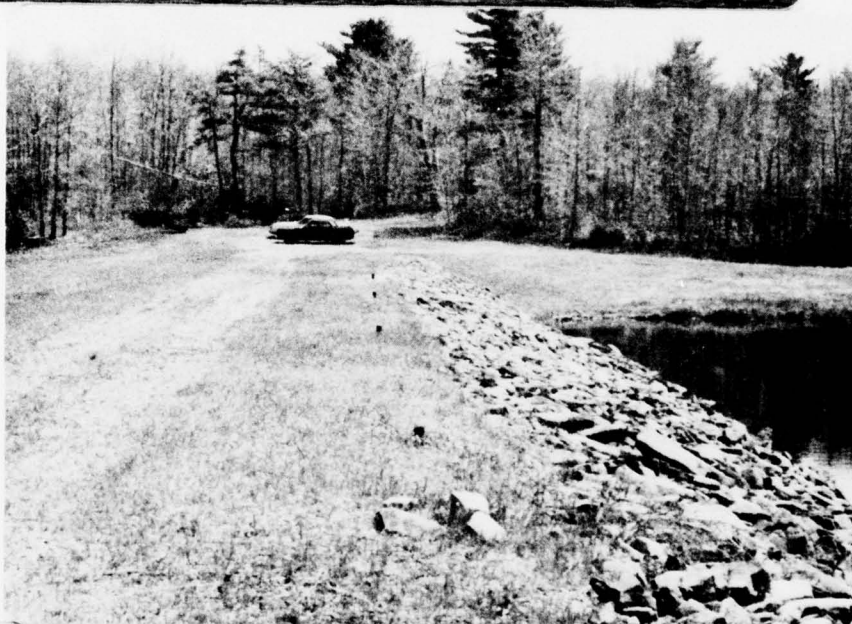
Right
Abutment

The dam embankment is maintained in fair condition. There is evidence of seepage on the slope and the toe was wet and soft in some areas. A few places on the embankment indicated mole activity. Between the embankment and the spillway is a large wet area. (See sketch in Appendix A). There was no evidence of cracking or visually detectable settlement in the embankment. Some sloughage has occurred close to the conduit. The riprap on the upstream slope and the dam crest road is in excellent condition. The drain near the downstream end of the spillway wall carried a considerable amount of water (Appendix D, Plate IV, top photograph).

1. The owner should investigate the need and feasibility of a toe drain for controlling seepage.
2. The owner should investigate the cause of and control the standing water on embankment near the spillway.
3. Backfill all woodchuck holes.

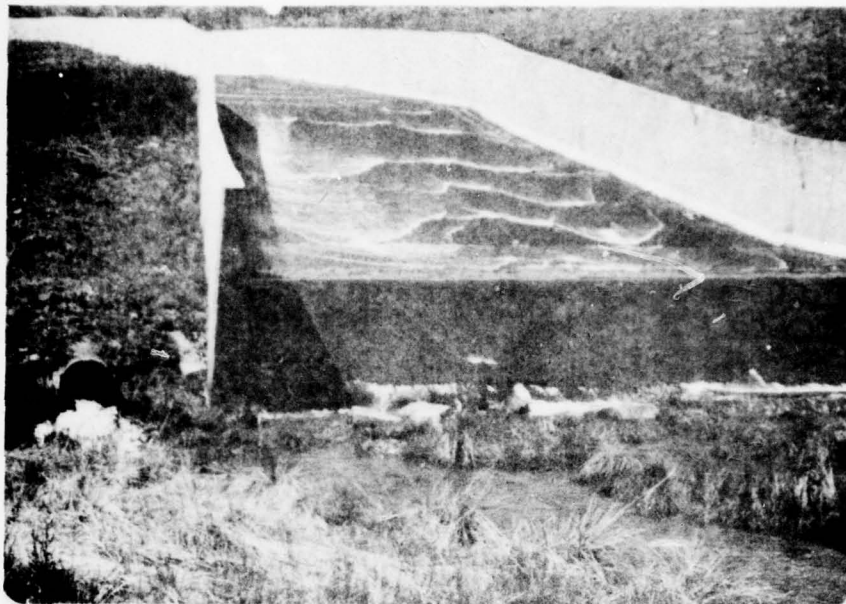
Stilling
Basin

The spillway crest and walls are in good condition, except for a few cracks. The spillway slab shows slight deterioration. Cracking is caused by the excessive length of individual monoliths.
